EFFECTS OF THE ATOMIC BOMB ON NAGASAKI,
JAPAN

Physical Damage Division

JUNE 1947

13 October-20 November 1945

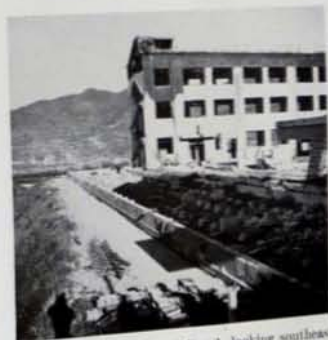
PHOTO 216.—Group 27, Building 1, looking southeast at southwest side.

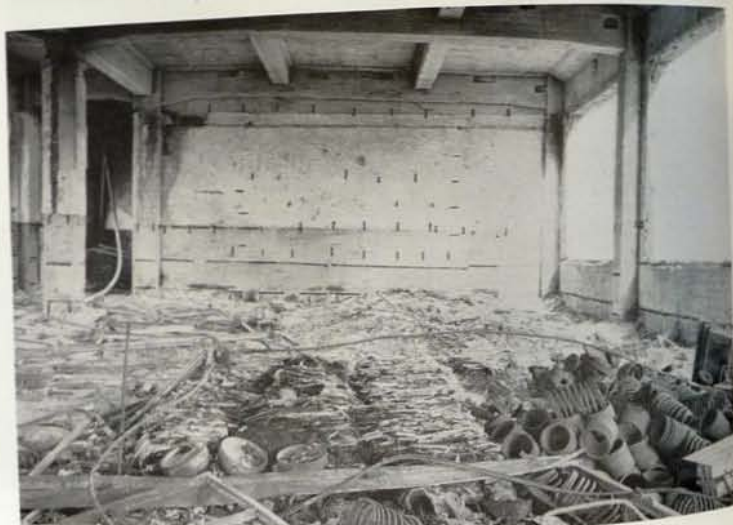
Construction	Damage			Description of damage
	Structural (per-cent)	Superficial (per-cent)	Cause	
Roof: Cement over waterproofing over reinforced-concrete slab and beams.	0	0		
Columns: Reinforced concrete, 24 by 24, 21 by 21, 18 by 18 inches.	0	0		
Third floor: Reinforced-concrete slab and beams.	5	0	Blast	Photo 214.
Second floor: Reinforced-concrete slab and beams.	5	0	do	
First floor: Reinforced-concrete slab and beams.	0	0		
Foundation: Reinforced-concrete footings.	0	0		
Exterior walls: Reinforced concrete.	0	40	Blast	Cracking of finish.
Interior walls: 25 percent reinforced concrete, 75 percent wood.	0	75	Blast and fire	All wood partitions burned.
Windows: Metal sash.	0	100	do	Blown out warped. Photos 215, 216, and 217.
Finish: Plaster and wood.	0	100	Fire	Burned out. Photos 213, 214, 217, and 218.
Contents: Furniture.	0	100	do	Consumed.

Photo 218.—Group 27, Building 1, complete combustion on third floor.

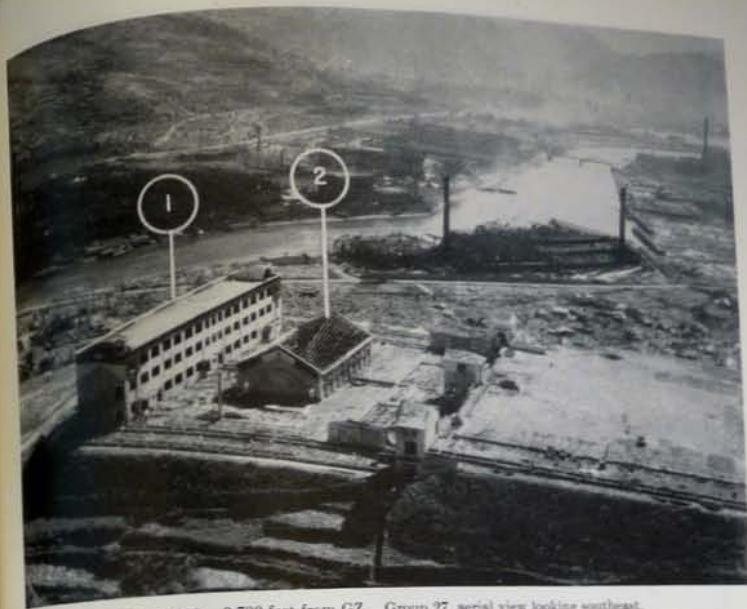
d. All of the wood members in Building 2 were destroyed by fire, and heat from the fire caused the collapse of the steel roof members (Photos 219 and 221).

Remarks: Nothing left but foundations and fireproof stair tower. Photo 219.

Photo 219.—3,700 feet from GZ. Group 27, aerial view looking southeast.

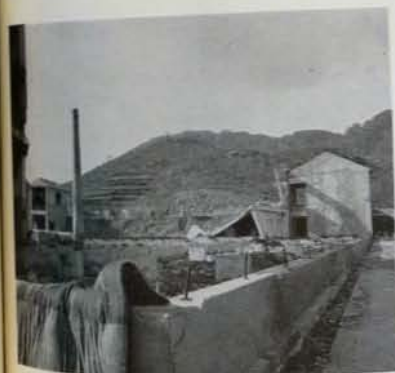
Photo 220.—Group 27, Building 7, looking southwest at destroyed structure.

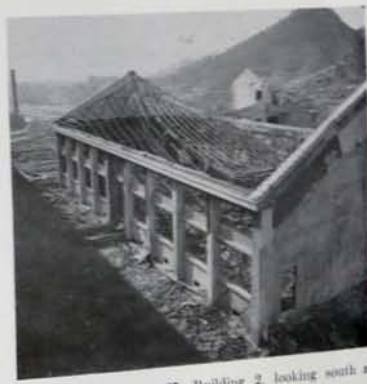
Photo 221.—Group 27, Building 2, looking south at destroyed roof.

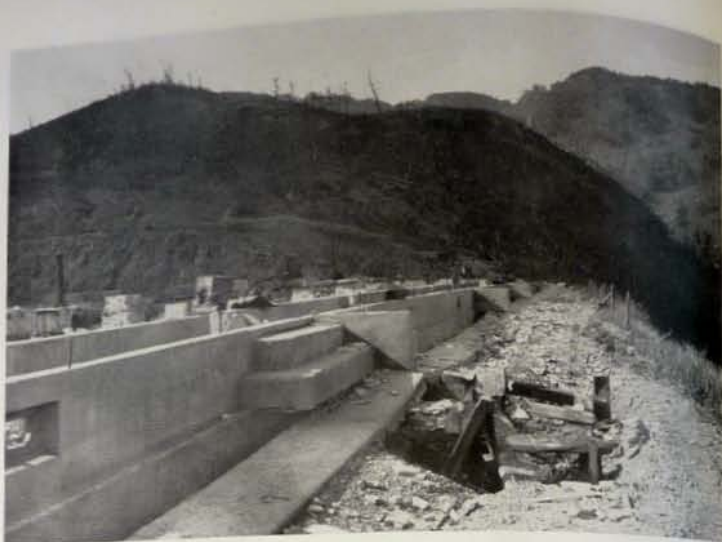
Remarks: Nothing left but foundations. Photo 222.

Photo 222—Group 27, Building 8, looking southwest at destroyed structure.

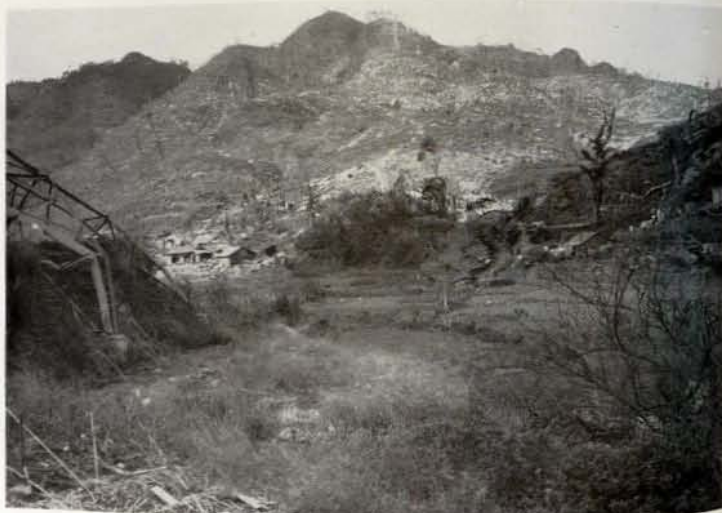
Photo 223.—3,800 feet from GZ. Group 27, scorched land west of school.

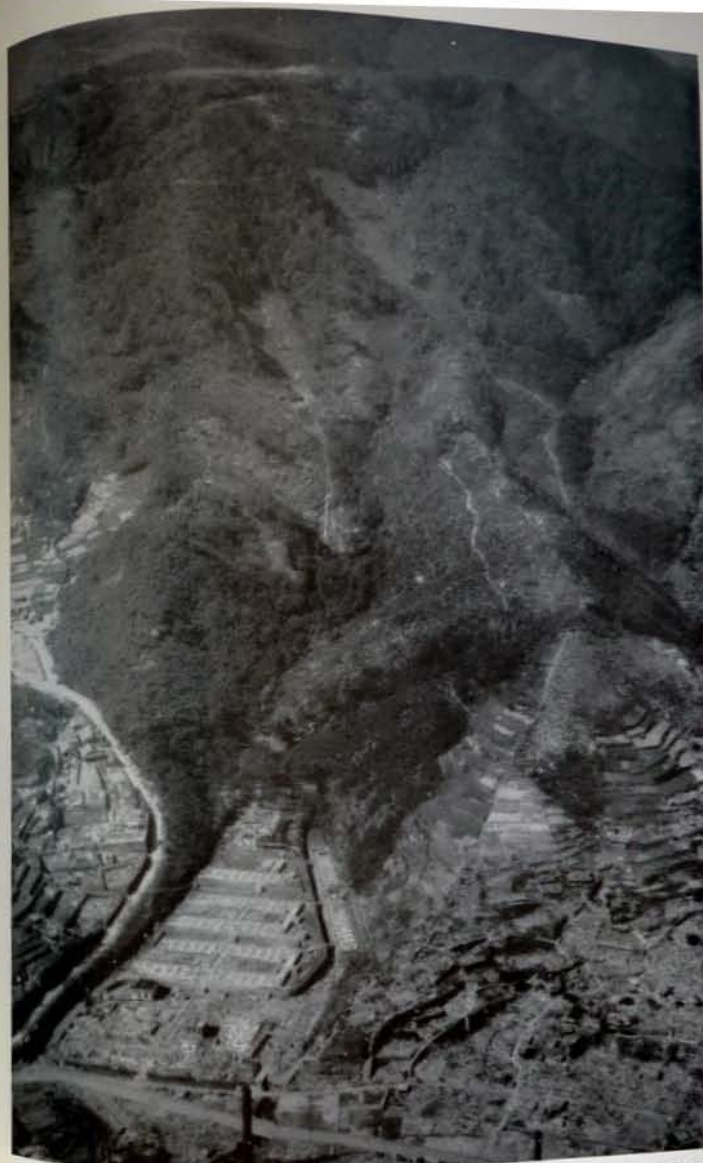
This group consisted of 22 buildings of various sizes all constructed of wood and located 4,900 feet southwest of GZ. All were destroyed by blast and fire (Photos 224 and 225).

Photo 224.—4,900 feet from GZ. Group 29, aerial view of Nagasaki Hygiene Experimental Center.

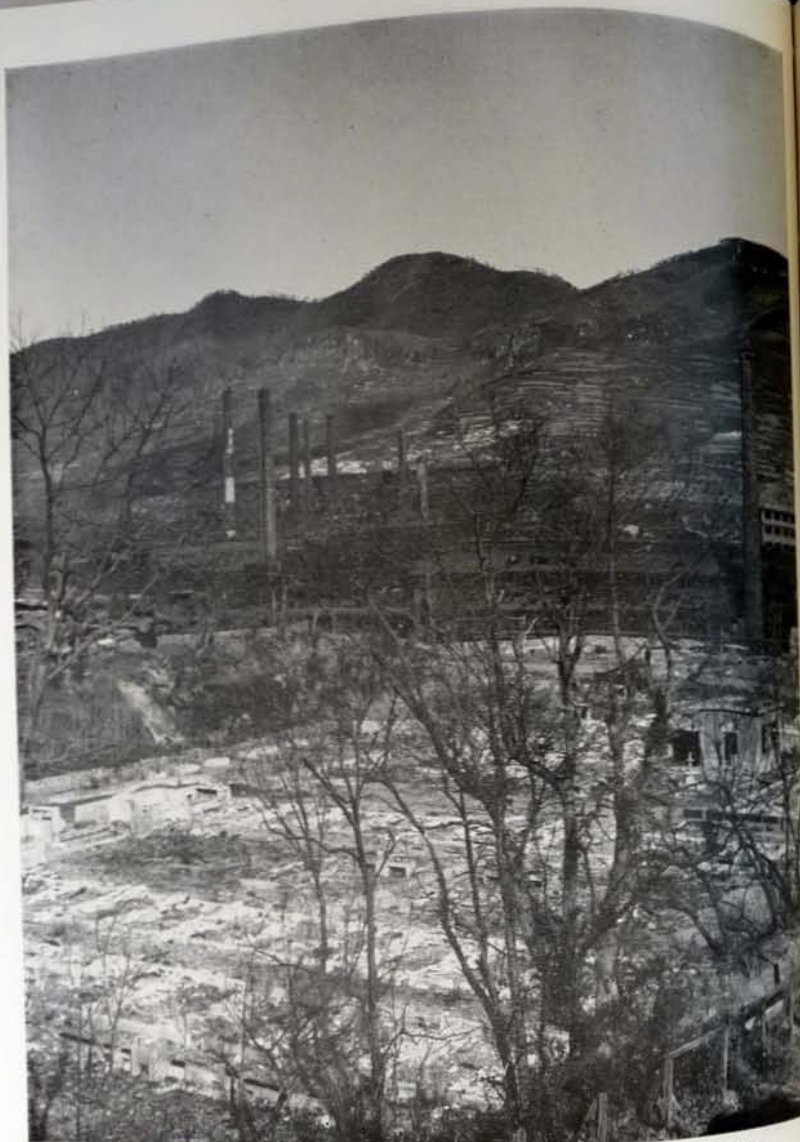
Photo 225.—4,900 feet from GZ. Group 29, remains of Nagasaki Hygiene Experimental Center.

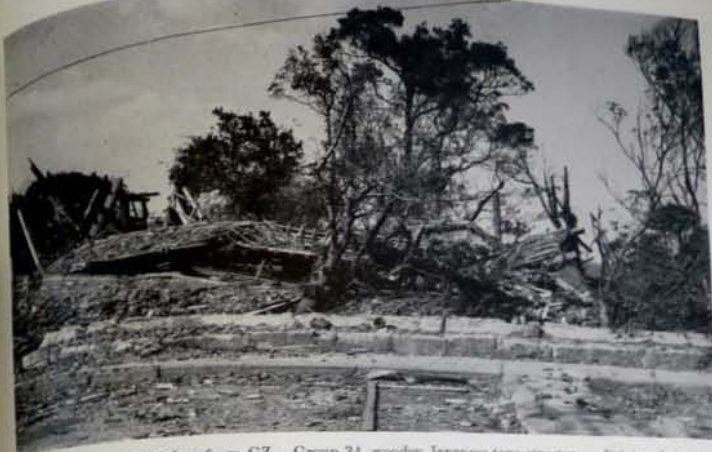
Photo 226.—5,600 feet from GZ. Group 34, wooden Japanese type structures adjoining shrine.

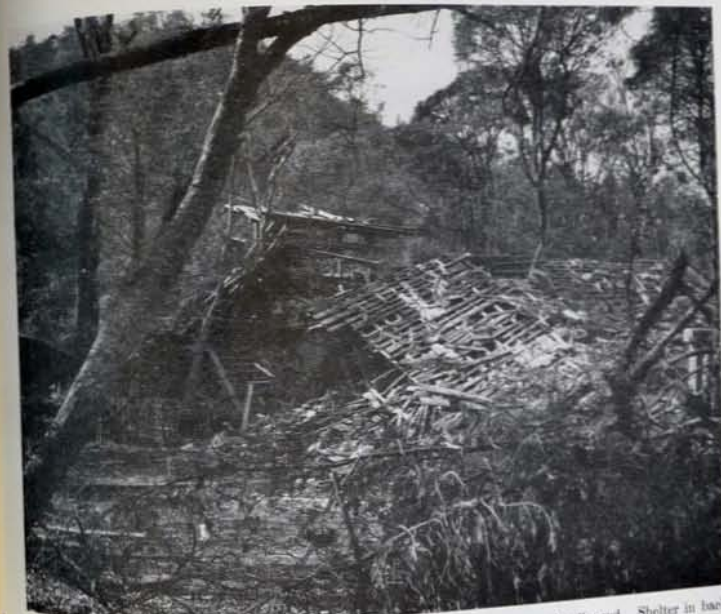
Photo 227.—5,600 feet from GZ. Group 34, Fuchi Shrine, building in foreground collapsed. Shelter in background wrecked.

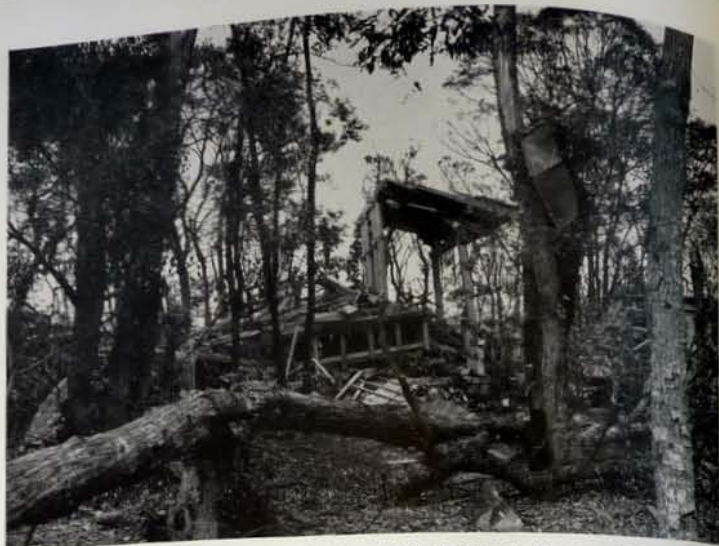
Photo 228.—5,600 feet from GZ. Group 34, Fuchi Shrine looking toward GZ.

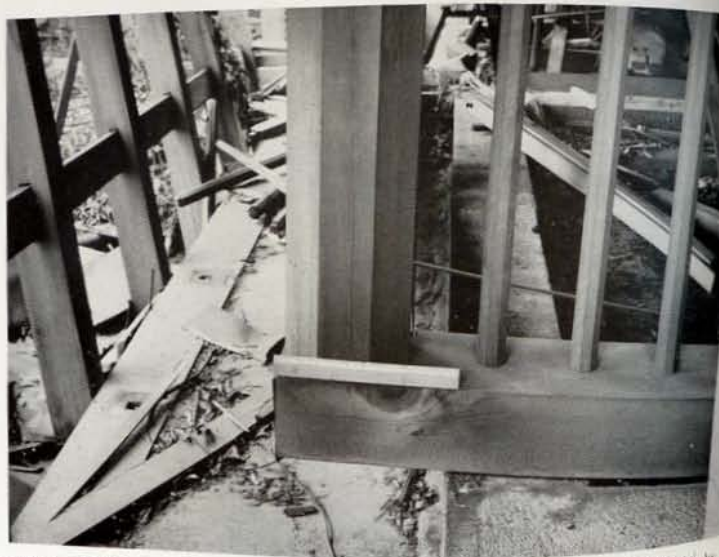
Photo 229.—5,600 feet from GZ. Group 34, wood superstructure, unanchored, moved south 12 inches by blast.

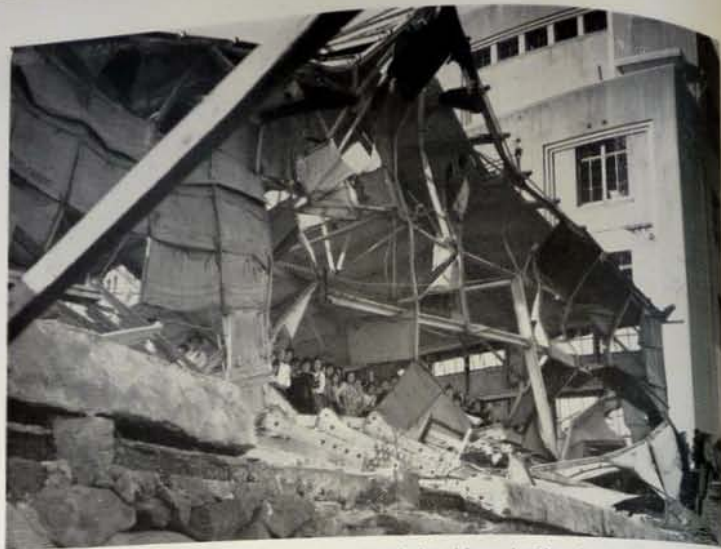
Photo 231.—Group 38, Building 1, view of north end of steel frame building damaged by blast.

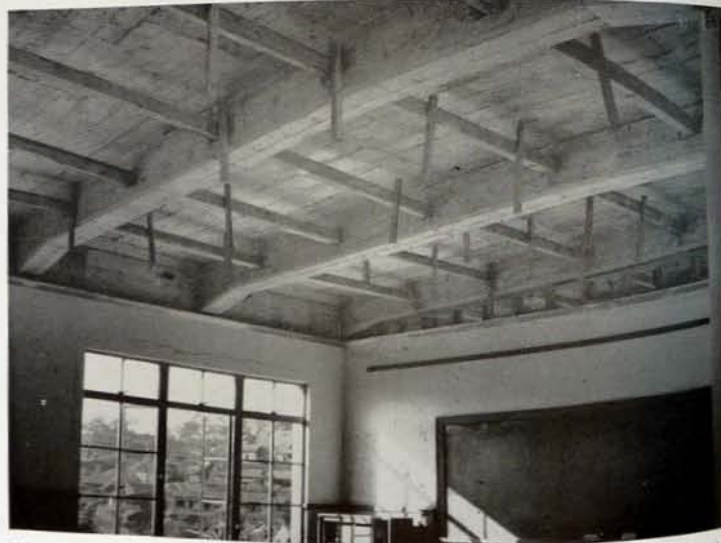
Photo 232.—Group 38, Building 3, typical concrete construction of structurally undamaged building. Plastered ceiling hung from wooden members have fallen.

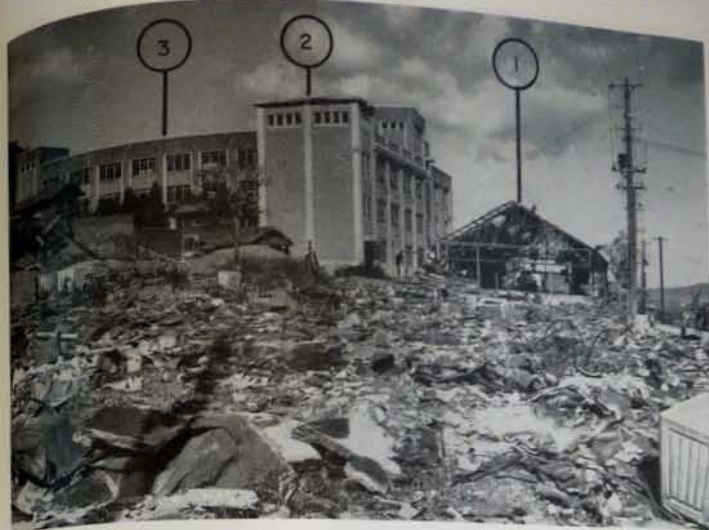
Photo 233.—Group 38, Buildings 1, 2, and 3, general view looking north at damaged steel-frame building at right and undamaged concrete buildings at left.

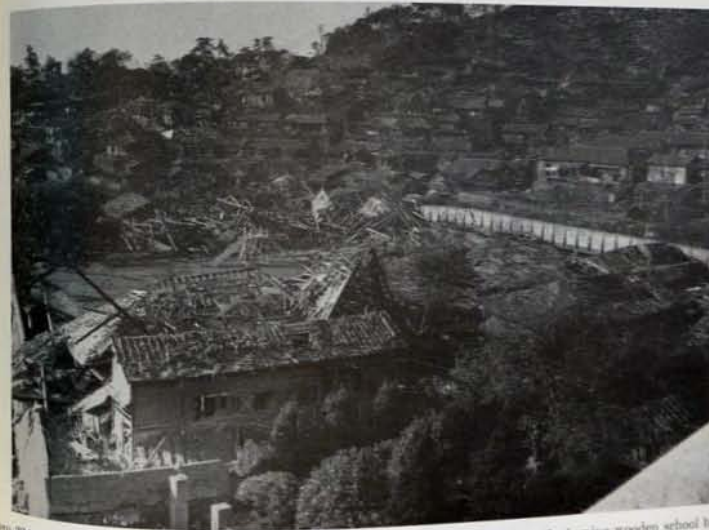
Photo 234.—6,300 feet from GZ. Group 38, Building 4, view from roof of Building 2, showing wooden school buildings destroyed by blast.

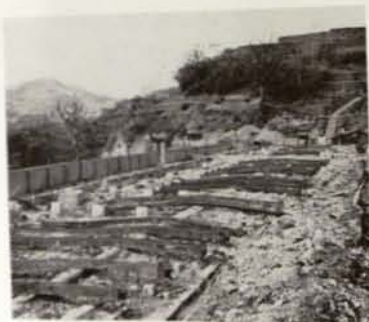
Photo 236.—6,500 feet from GZ. Group 42, Building 1, looking north at remains and steel framing.

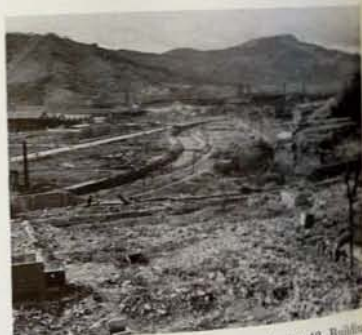
Photo 237.—6,800 feet from GZ. Group 42, Building 4, looking northwest at remains.

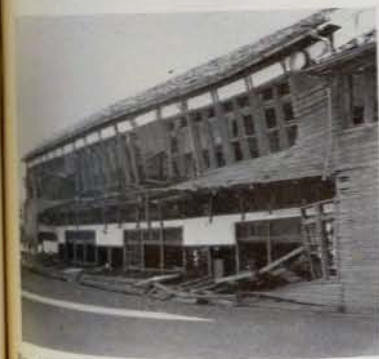
Photo 239.—8,300 feet from GZ. Group 48, Building 4, wall of two-story, wood-frame building distorted by blast from atomic bomb.

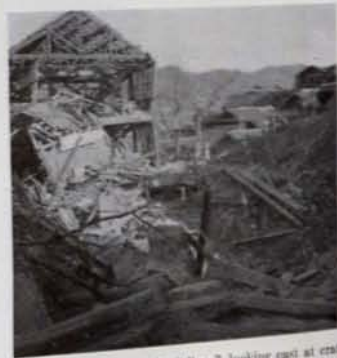
Photo 240.—Group 48, Building 3 looking east at crater and debris caused by 500-pound, high-explosive bomb prior to atomic-bomb attack.

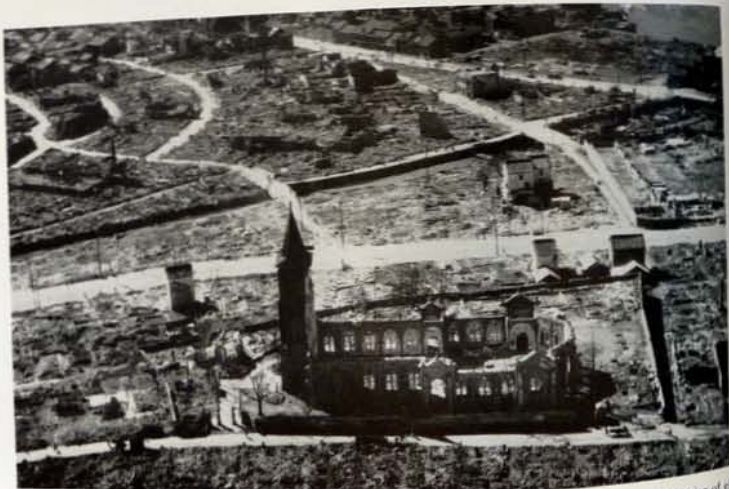
Photo 242.—8,800 feet from GZ. Group 70, Building 1, aerial view, looking south at burned-out interior of church.

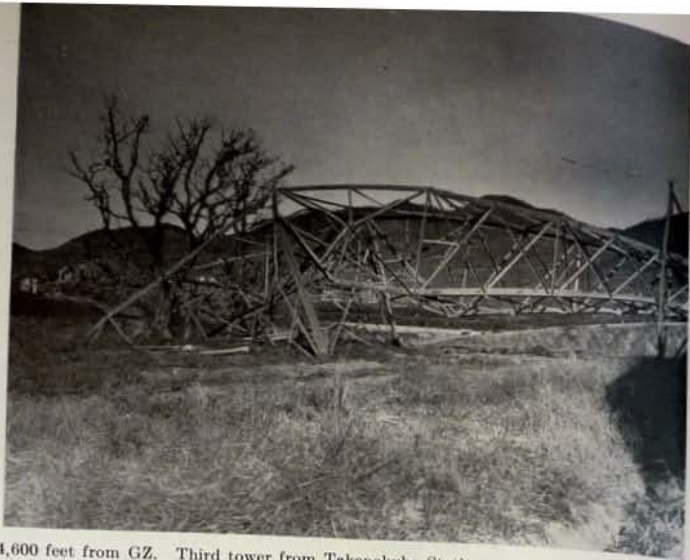
PHOTO 1.—4,600 feet from GZ. Third tower from Takenokubo Station on tap line from Zenza-Mukohina line.

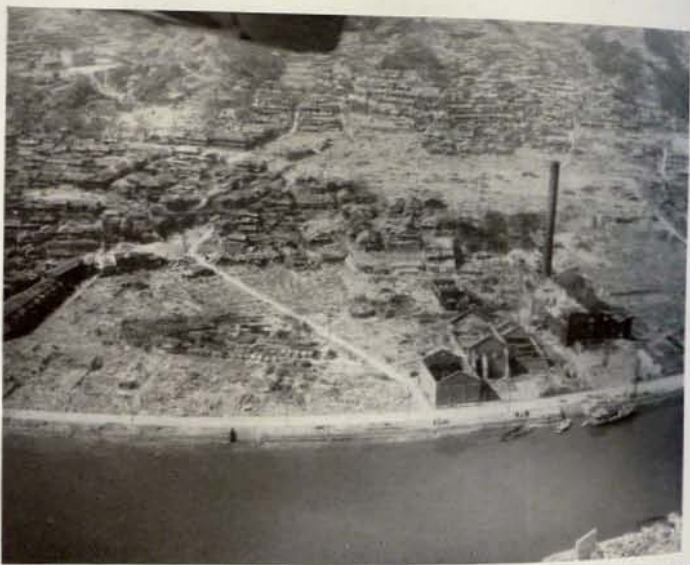
PHOTO 2.—6,700 feet from GZ. Aerial view of 3,000-kilowatt steam-electric generating station.

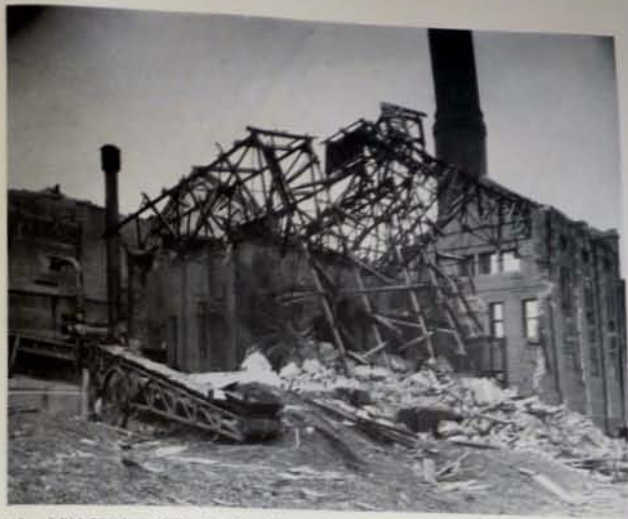
PHOTO 3.—6,700 feet from GZ. Interior of boiler room, looking west, steam-electric generating station.

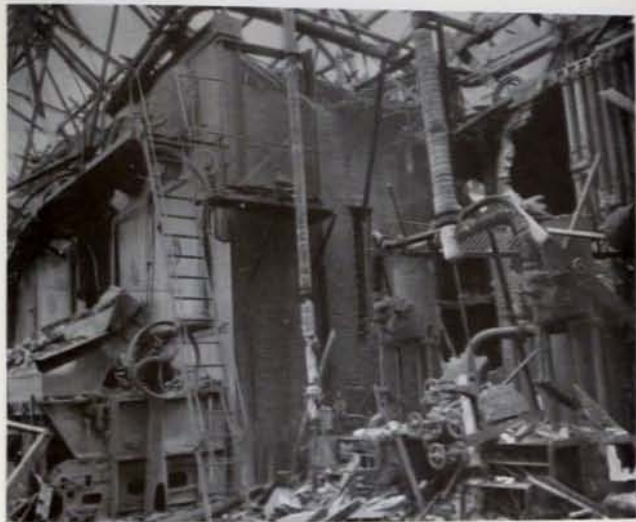
PHOTO 4.—6,700 feet from GZ. Interior view of boiler room, looking west, steam-electric generating station.

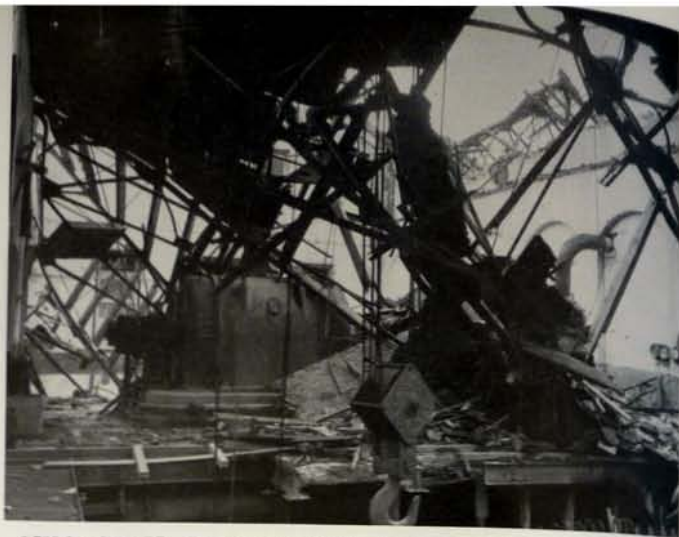
PHOTO 5.—6,700 feet from GZ. Side view of turbo-generator, looking west, steam-electric generating station.

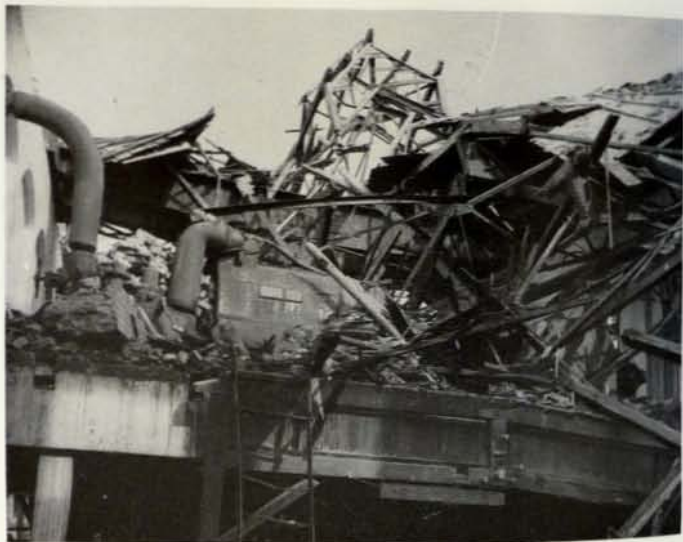
PHOTO 6.—6,700 feet from GZ. Side view of turbo-generator, looking east, steam-electric generating station.

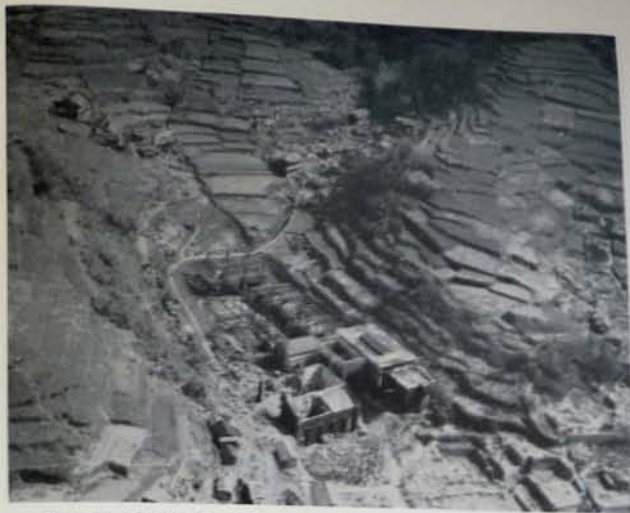
PHOTO 7.—5,400 feet from GZ. Aerial view, looking northeast, Zenze Substation.

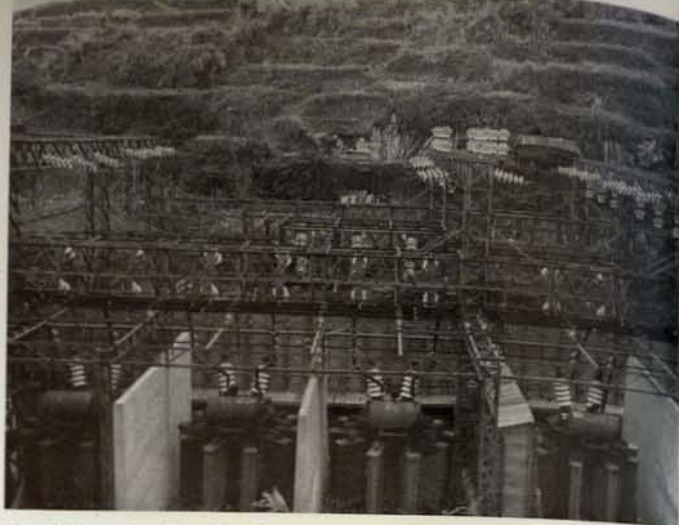
Considerable effort was made to protect electric equipment against air attacks. Concrete, and earth-filled wood blast walls were used extensively with good results. These types are shown in Photos 9, 17 to 20, 26, and 43.

PHOTO 9.—5,400 feet from GZ. East side view of transformers with blast walls at Zenza Substation.

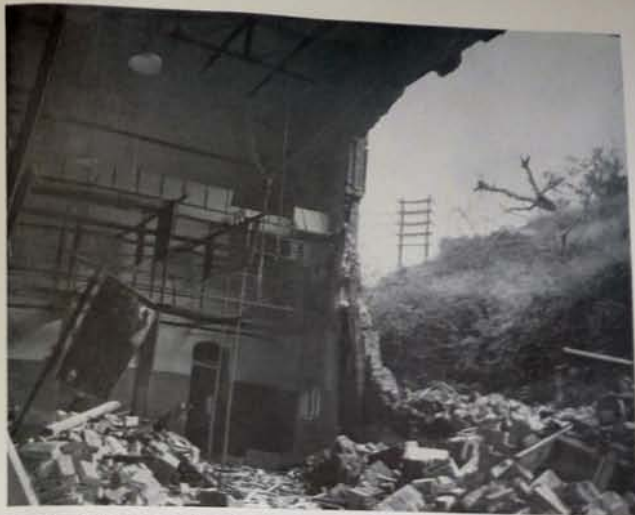
PHOTO 11.—5,400 feet from GZ. Southeast corner of control and switch room, Zenza Substation.

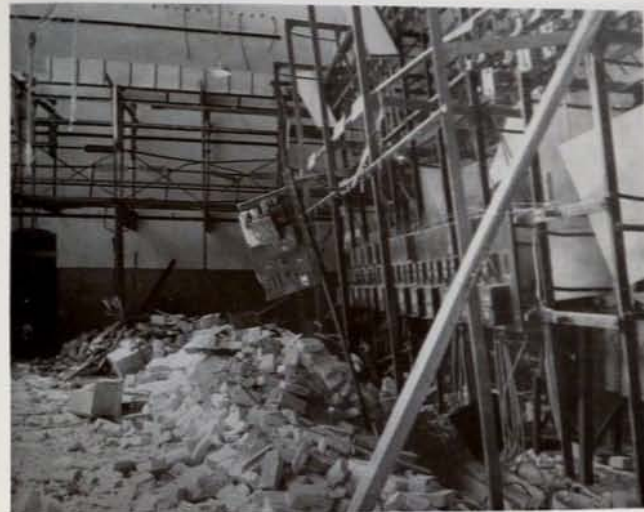
PHOTO 12.—5,400 feet from GZ. Controls, 3.5-kilovolt busses and oil circuit breakers, Zenza Substation.

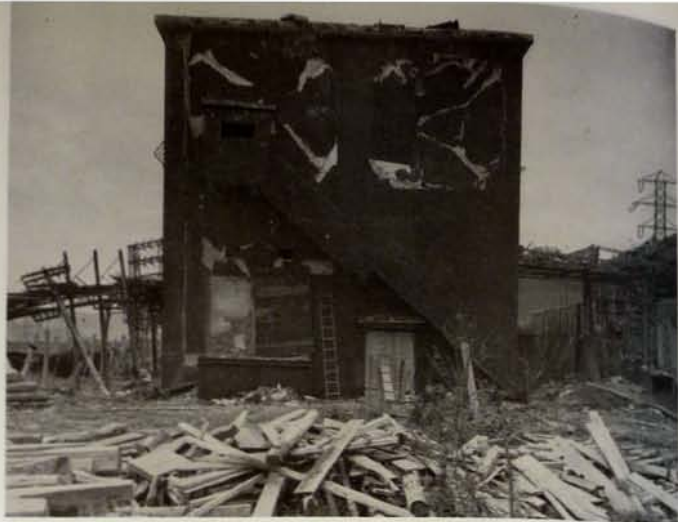
PHOTO 13.—3,600 feet from GZ. North end of control and switch building, Takenokubo Substation.

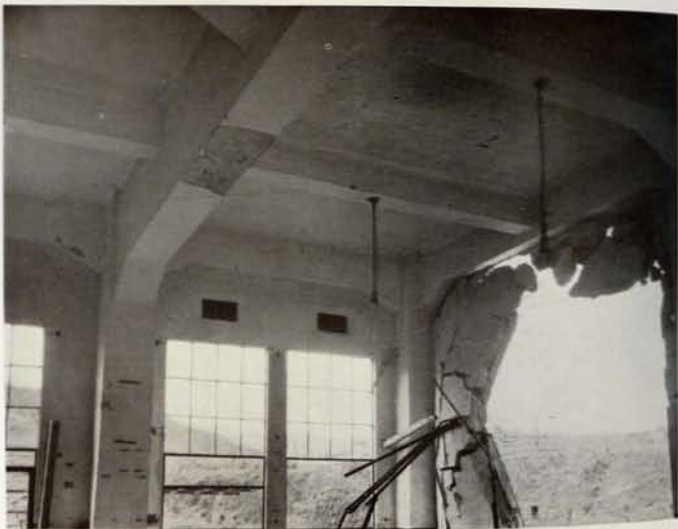
PHOTO 14.—3,600 feet from GZ. Interior view, northeast corner of control room (second floor), Takenokubo Substation.

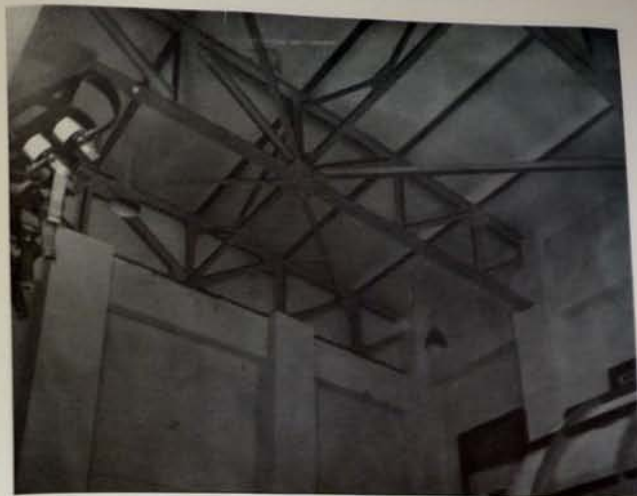
PHOTO 15.—3,600 feet from GZ. Southeast corner synchronous condenser room, first floor, of switch building, Takenokubo Substation.

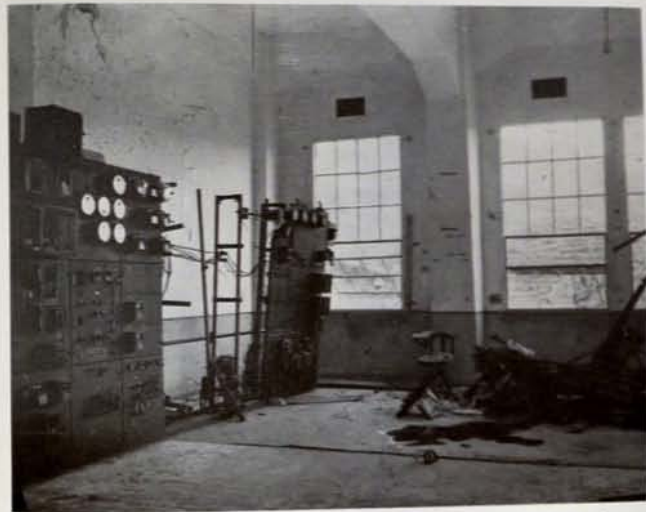
PHOTO 16.—3,600 feet from GZ. View of control room. Takenokubo Substation.

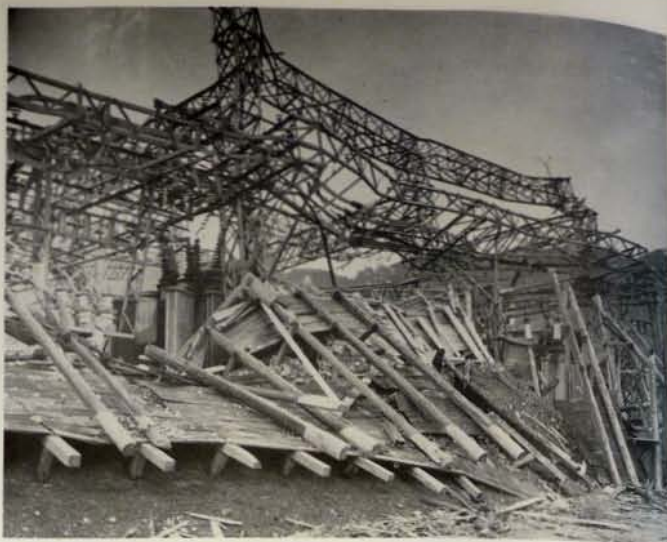
PHOTO 17.—3,600 feet from GZ. Wooden dirt filled blast walls on north side of transformers, Takenokubo Substation.

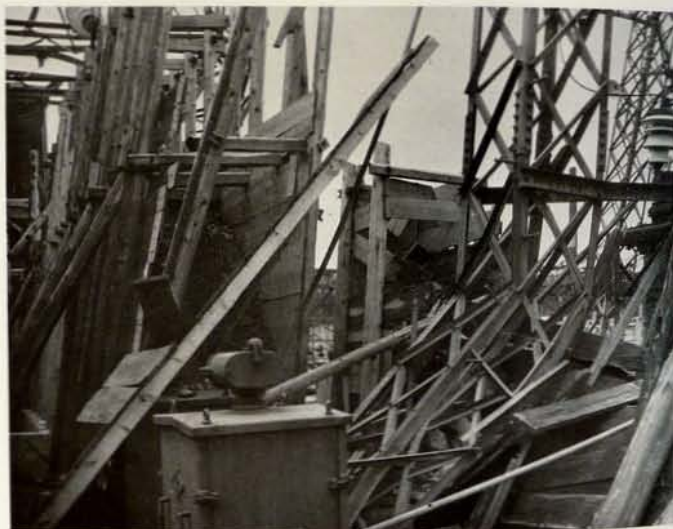
PHOTO 18.—3,600 feet from GZ. Blast wall separating transformer bays from high voltage switches. Wall blown over and tower in wall distorted. Takenokubo Substation.

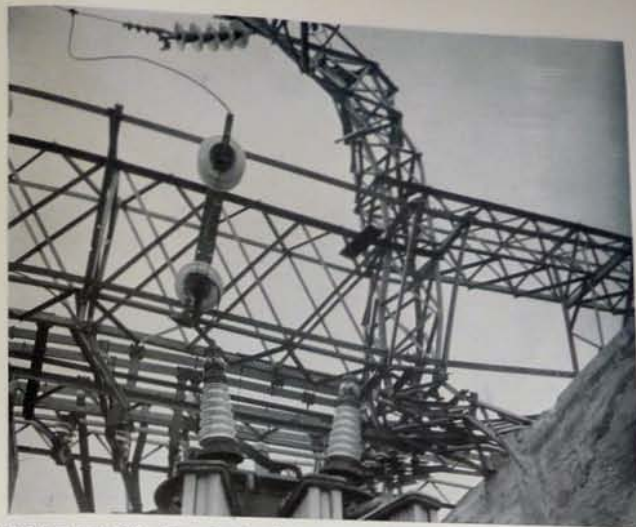
PHOTO 19.—3,600 feet from GZ. View showing displacement and distortion of rack. Disconnect switch shown was originally over the bushing on the right. Takenokubo Substation.

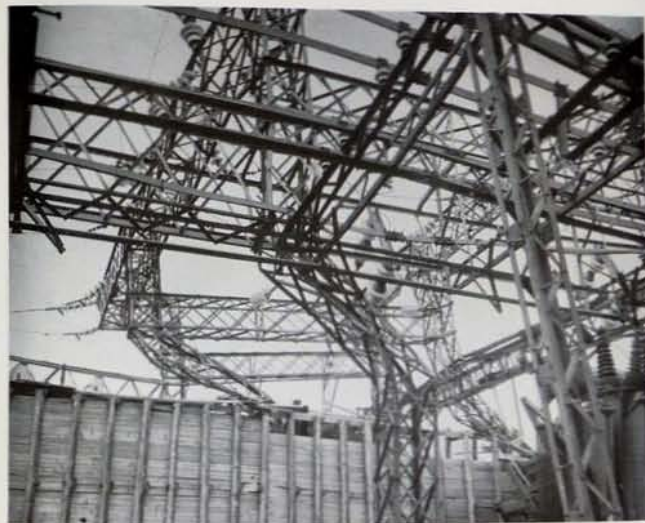
PHOTO 20.—3,600 feet from GZ. Looking southwest through the rack at the distortion of main steel towers, Takenokubo Substation.

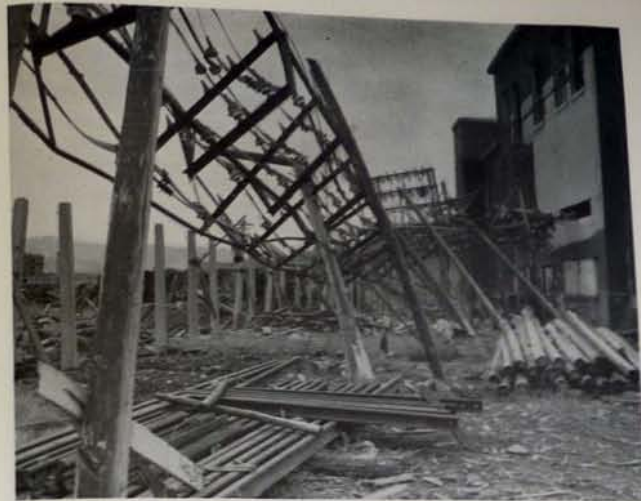
Photo 23.—3,600 feet from GZ. Three circuit copper bus structure. Note flash burns on poles. Takenokubo Substation.

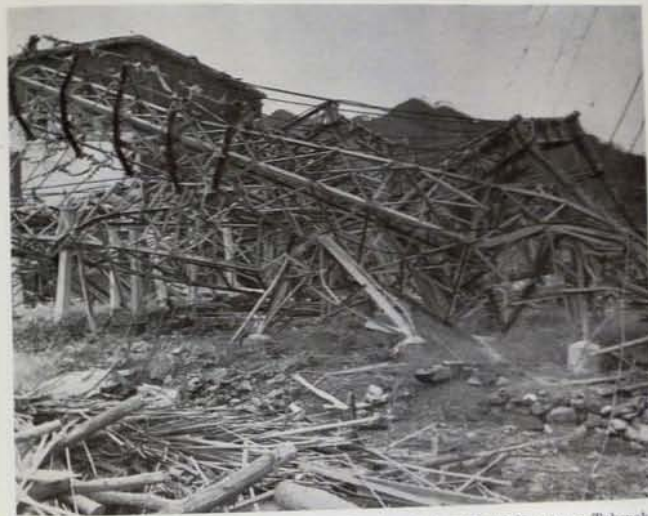
Photo 24.—3,600 feet from GZ. Looking southeast at 3.5-kilovolt switch rack and first tower, Takenokubo Substation.

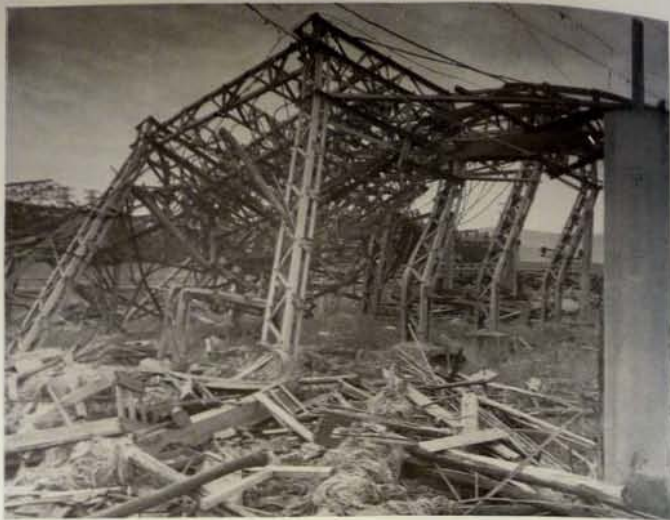
Photo 25.—3,600 feet from GZ. Looking northwest at 3.5-kilovolt switch rack, Takenokubo Substation.

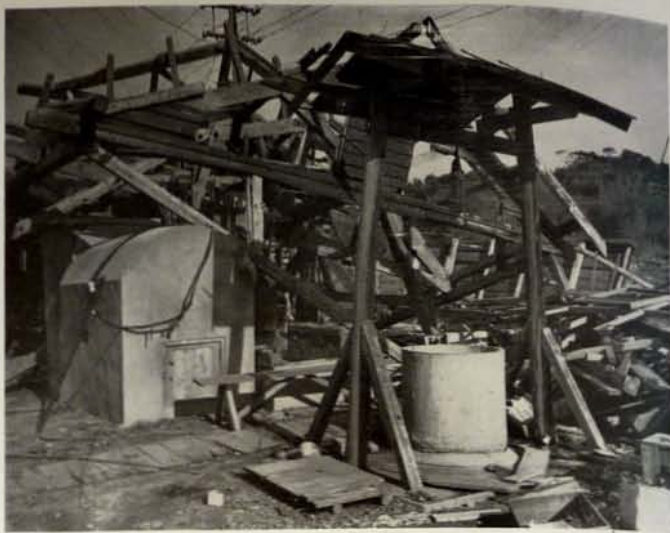
PHOTO 29.—5,200 feet from GZ. Remains of control building. Concrete structure was air-raid shelter for operators.
Urakami Substation.

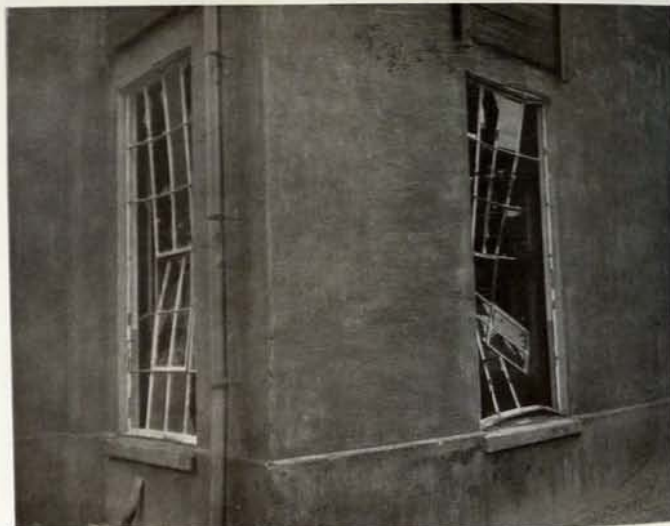
PHOTO 30.—10,500 feet from GZ. Southeast corner of control building, Akunoura Substation.

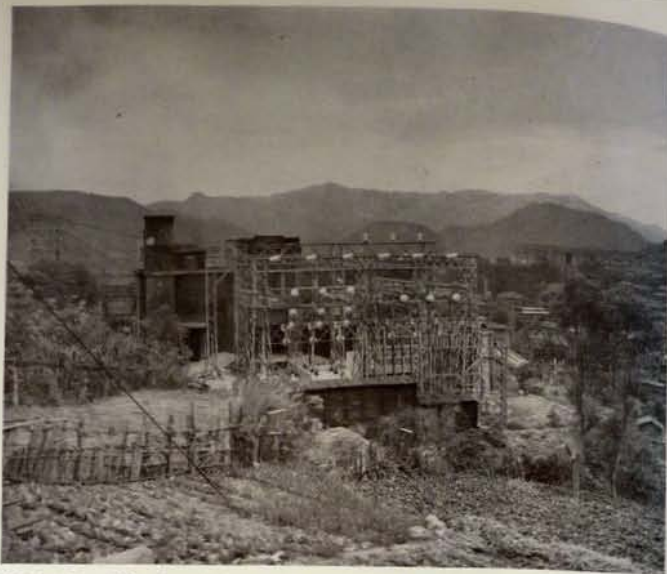
r. The high-voltage section of the station was used only for a sectionalizing breaker in the high-tension lines to and from the station. Photo 33 is a general view of that part of the station.

PHOTO 33.—10,500 feet from GZ. General view showing incoming 66-kilovolt lines, rack and buildings, Akunoura Substation.

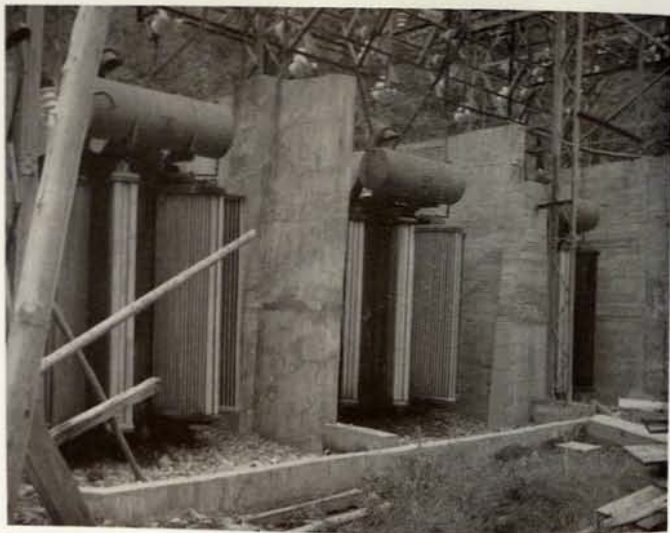
PHOTO 38.—15,000 feet from GZ. Transformer bank and blast walls, Tategami Substation.

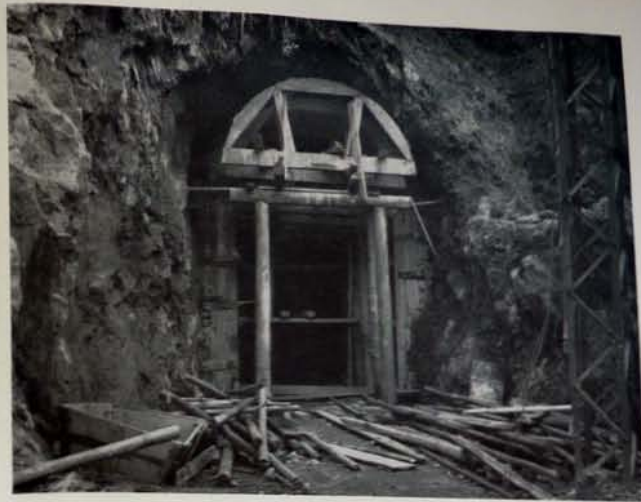
y. Plans had been made for, and construction had been started on, a tunnel in order to place the station underground, like the Mukoshima station. Photo 39 is a view of the tunnel entrance and Photo 40 shows the location of the present station with respect to the tunnel. Photo 41 shows the 3.5-kilovolt switch rack and circuits leaving the switch building.

PHOTO 39.—15,000 feet from GZ. Entrance to underground transformer room (not completed).

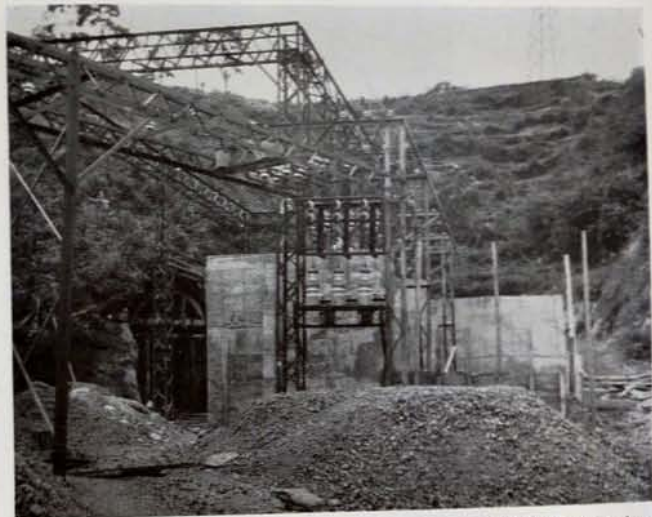
PHOTO 40.—15,000 feet from GZ. Location of new underground transformer room with respect to the present station, Tategami Substation.

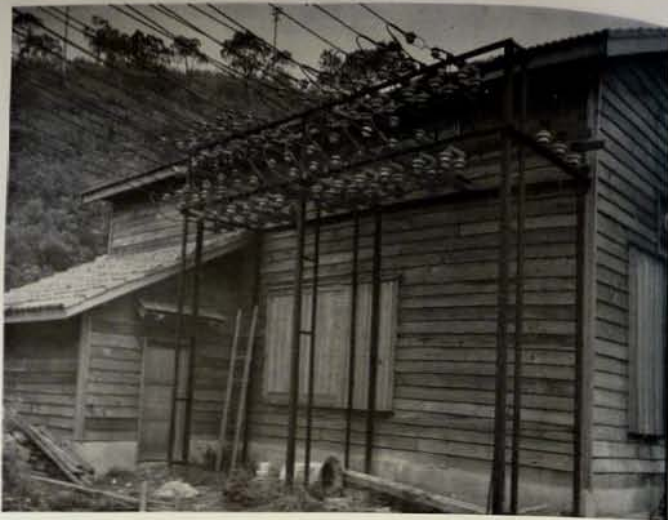
PHOTO 41.—15,000 feet from GZ. 3.5-kilovolt switch rack and circuit entrance to control building, Tategami Substation.

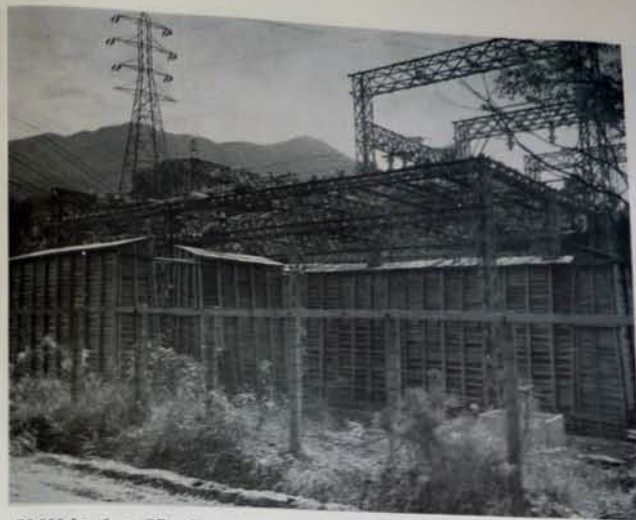
z. *Egawa station.*—This station was located 30,000 feet south of GZ. There were two banks of two 1,000-kilovolt-ampere transformers connected open delta, with sufficient switches installed to change to one bank connected delta with a spare transformer—a very unusual switching arrangement. The transformers were protected by the usual wooden, earth-filled, blast walls. Photos 42 and 43 are general views of the station. It was not damaged.

PHOTO 43.—30,000 feet from GZ. General view of west side of substation, bus structure, and Egawa Substation.

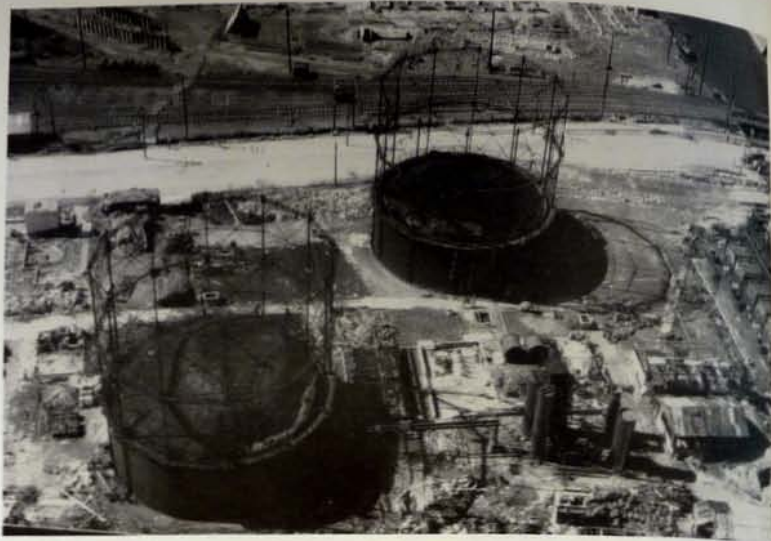
Photo 45.—6,600 feet from GZ. Aerial view of gas holders, Yachiyo-Machi Gas Works.

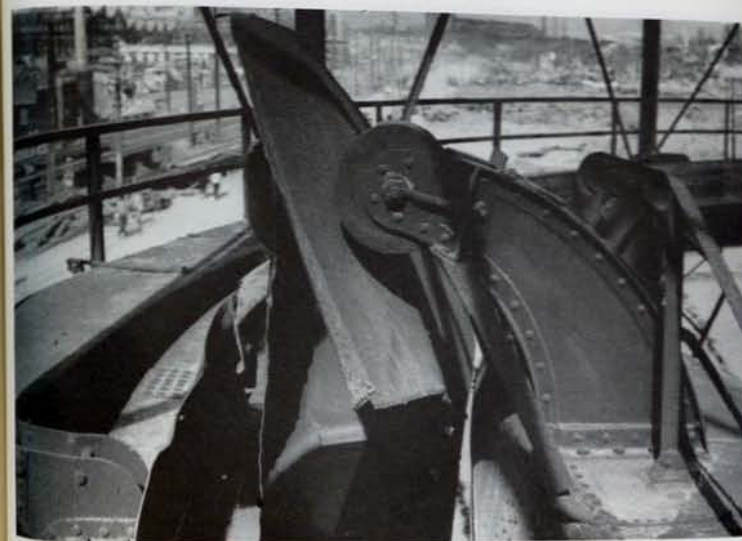
Photo 48.—6,600 feet from GZ. Displaced guide roller on inner tank of Gas Holder 1, Yachiyo-Machi Gas Works.

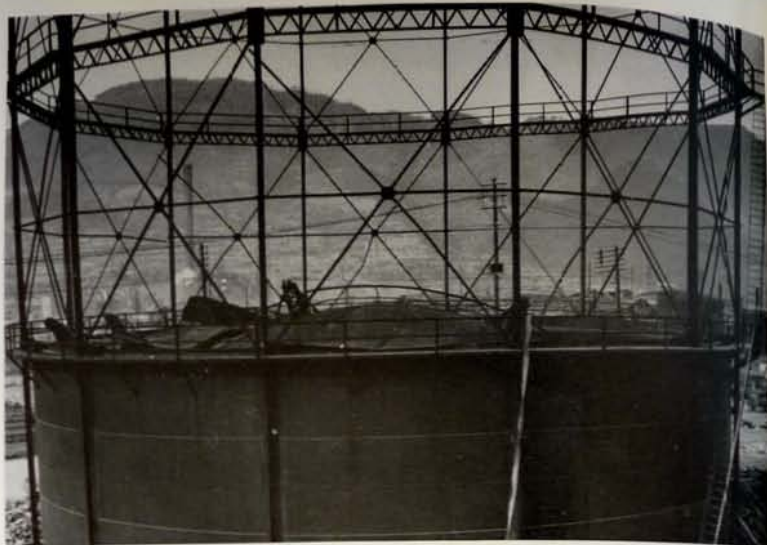
PHOTO 49.—6,600 feet from GZ. Gas Holder 2 showing damaged tank top, Yachiyo-Machi Gas Works.

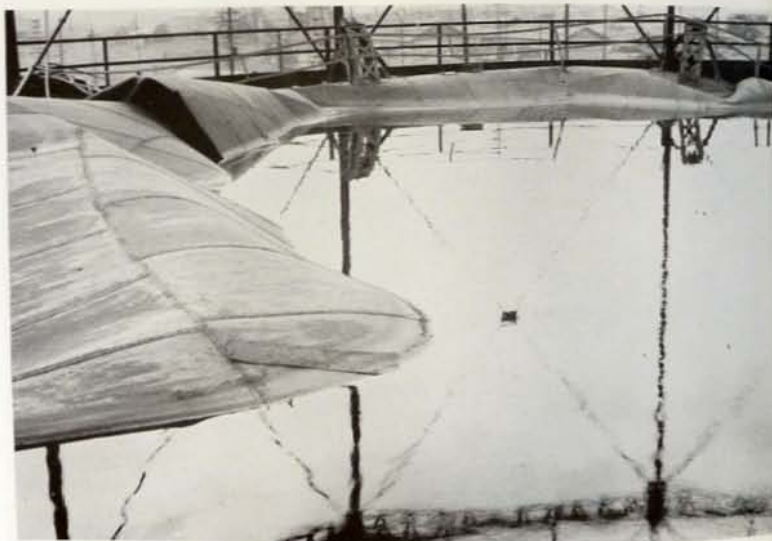
PHOTO 50.—6,600 feet from GZ. View of collapsed tank top, Gas Holder 2, Yachiyo-Machi Gas Works.

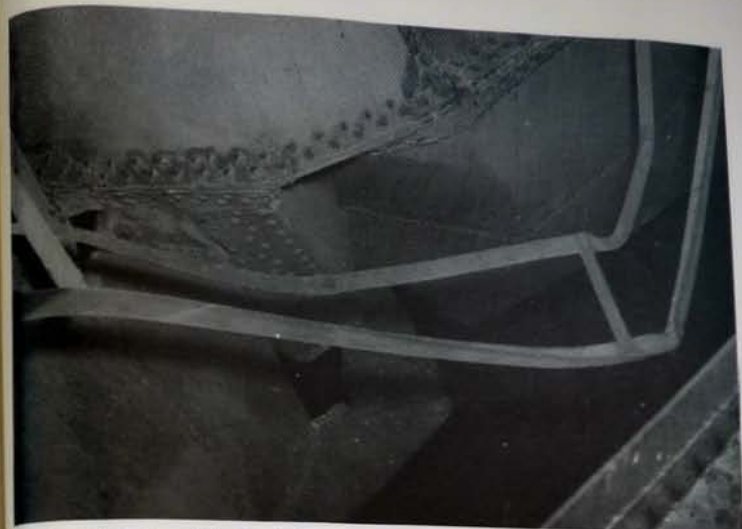
PHOTO 51.—6,600 feet from GZ. Detailed view of sheared tank top Gas Holder 1, Yachiyo-Machi Gas Works.

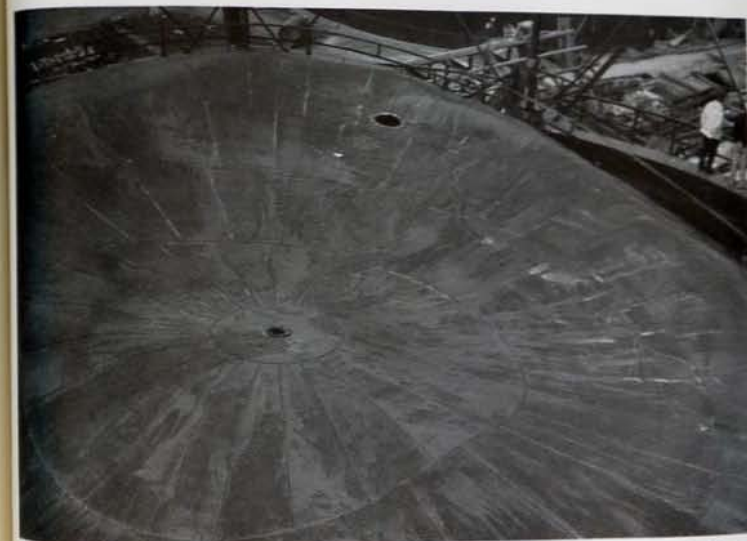
PHOTO 52.—6,600 feet from GZ. View of deformed tank top of Gas Holder 1, Yachiyo-Machi Gas Works.

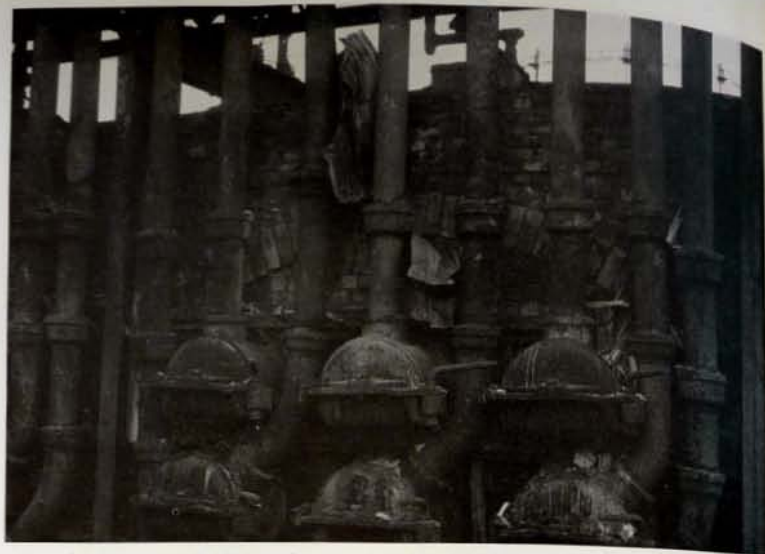
Damage to other equipment was slight. The roof covering the retorts was blown away with minor damage to the retorts themselves, which was evidenced by loosened brickwork, loose pipe connections, and broken retort doors (Photos 53,

PHOTO 53.—6,600 feet from GZ. Detail of gas retort, Yachiyo-Machi Gas Works.
